# Snake River Watershed Stressor Identification Report

A study of the local stressors that are limiting the impaired fish and macroinvertebrate communities in the Snake River Watershed.

Document number: wq-ws5-09020309a

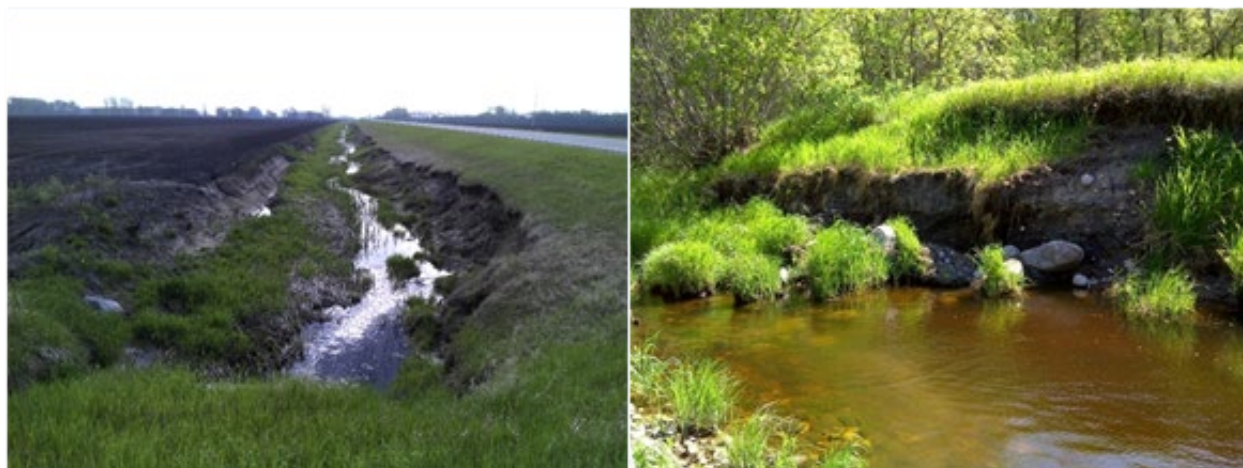
Figure 8. Images of sediment sources to AUID 543, including bank slumping along an unnamed ditch at the 200<sup>th</sup> Avenue NW and CSAH 14 intersection on May 28, 2014 (left), courtesy of Clark and Vinje (2017); and bank erosion near Station 13RD104 on May 29, 2014 (right), courtesy of Clark and Vinje (2017).

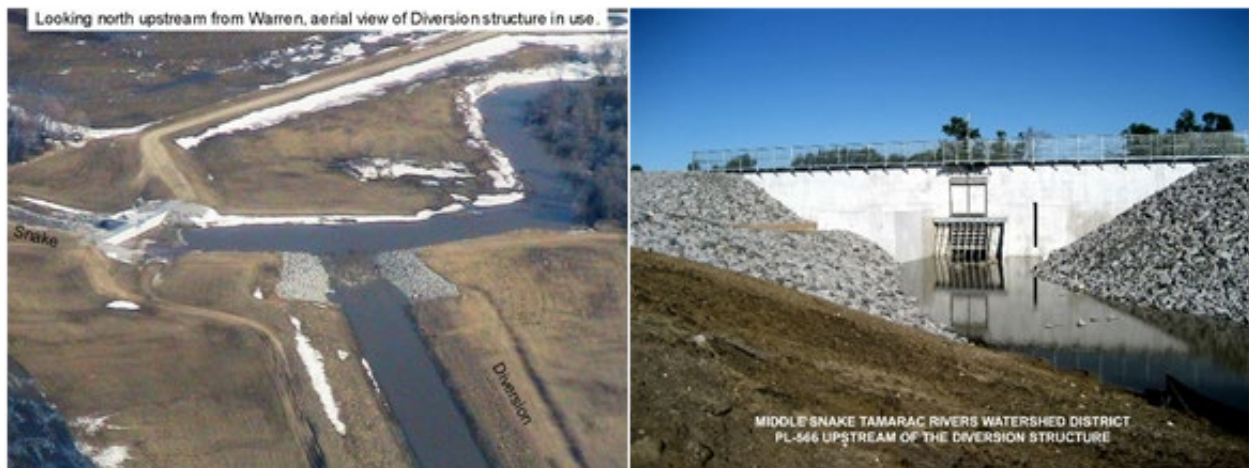
Figure 12. Images of the Warren Diversion Dam and associated diversion channel on an unspecified date (left), courtesy of the MSTRWD; and the upstream side of the Warren Diversion Dam on an unspecified date (right), courtesy of the MSTRWD.

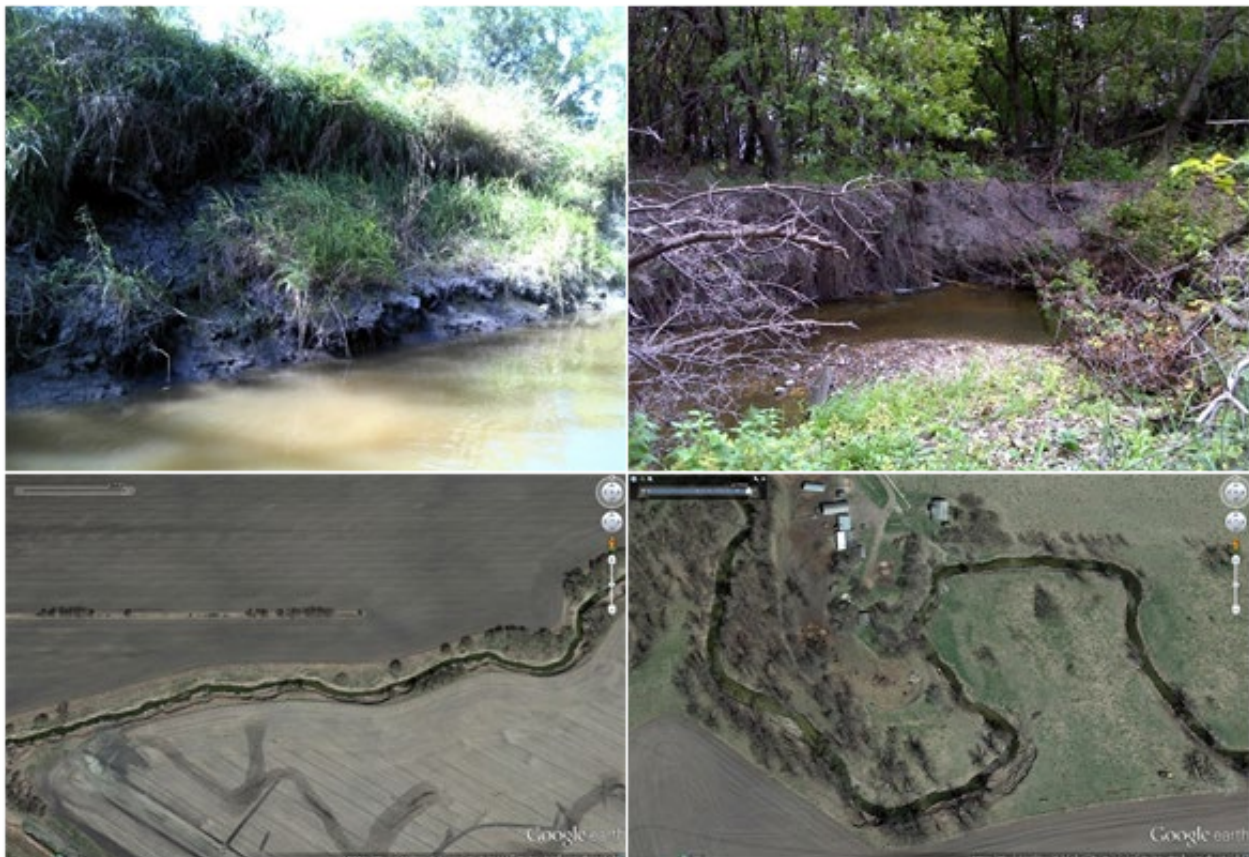
Figure 15. Images of sediment sources along AUID 504, including bank slumping near Station 13RD004 on September 17, 2014 (upper left), courtesy of Clark and Vinje (2017); bank cutting at Station 13RD108 on September 17, 2015 (upper right), courtesy of Clark and Vinje (2017); streambank erosion near 400<sup>th</sup> Avenue NW on April 29, 2016 (lower left), courtesy of Google Earth; and streambank erosion near 230<sup>th</sup> Street NW on April 29, 2016 (lower right), courtesy of Google Earth.

level of embeddedness of coarse substrate documented at Stations 05RD175, 13RD004, and 93RD416. Overall, the available data suggest that the reach experiences frequent periods of high suspended sediment. According to Clark and Vinje (2017), mass erosion caused by incision is a contributing source of excess sediment to the reach. Figure 15 shows images of streambank instability along the reach.

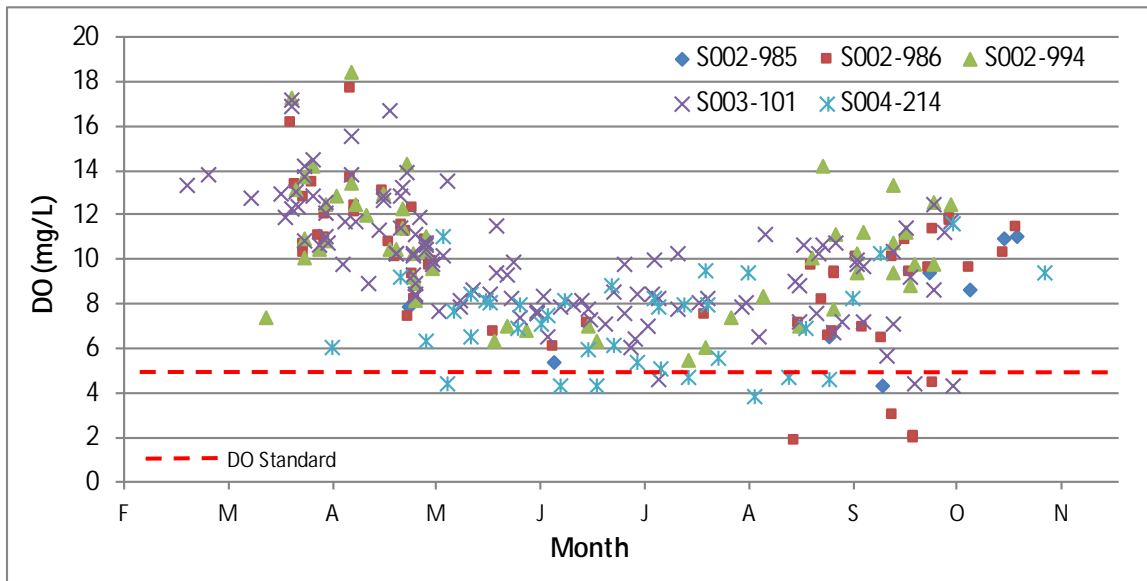
The MPCA biological monitoring staff collected a combined five discrete DO measurements at Stations 05RD175, 13RD108, and 93RD416 along AUID 504 at the time of fish and macroinvertebrate monitoring. Measurement values ranged from 6.6 to 11.0 mg/L. Figure 16 displays all available discrete DO data for Sites S002-985 (North 2<sup>nd</sup> Street crossing; 1999-2001;  $n=9$ ), S002-986 (1999-2015;  $n=58$ ), S002-994 (2002-2015;  $n=54$ ), S003-101 (2003-2015;  $n=118$ ), and S004-214 (1998-2014;  $n=38$ ); the location of each site is shown in Figure 11. Collectively, 6% of the DO values for the sites were below the standard; however, only 23 of the measurements were collected prior to 9:00 a.m. Generally, the lowest DO levels were in the months of June, July, and August. During this period, stream flow is usually low and water temperature is high. The MPCA conducted continuous DO monitoring at Site H68031002 (CSAH 34 crossing) from July 1, 2015, to July 15, 2015; the location of the site is shown in Figure 11. The monitoring results are provided in Table 12, as well as displayed in Figure 17. None of the DO measurements within the monitoring period were below the standard. A large rain event ( $\approx 2-3''$ ) interrupted the diurnal pattern on and after July 5, 2015. Additionally, the SRW HSPF model estimates that the reach had a DO concentration below the standard less than 1% of the time during the period of 1996 to 2009. Overall, the available data suggest that the reach experiences occasional periods of low DO.

Figure 16. Discrete DO data for Sites S002-985 (1999-2001;  $n=9$ ), S002-986 (1999-2015;  $n=58$ ), S002-994 (2002-2015;  $n=54$ ), S003-101 (2003-2015;  $n=118$ ), and S004-214 (1998-2014;  $n=38$ ) along AUID 504.

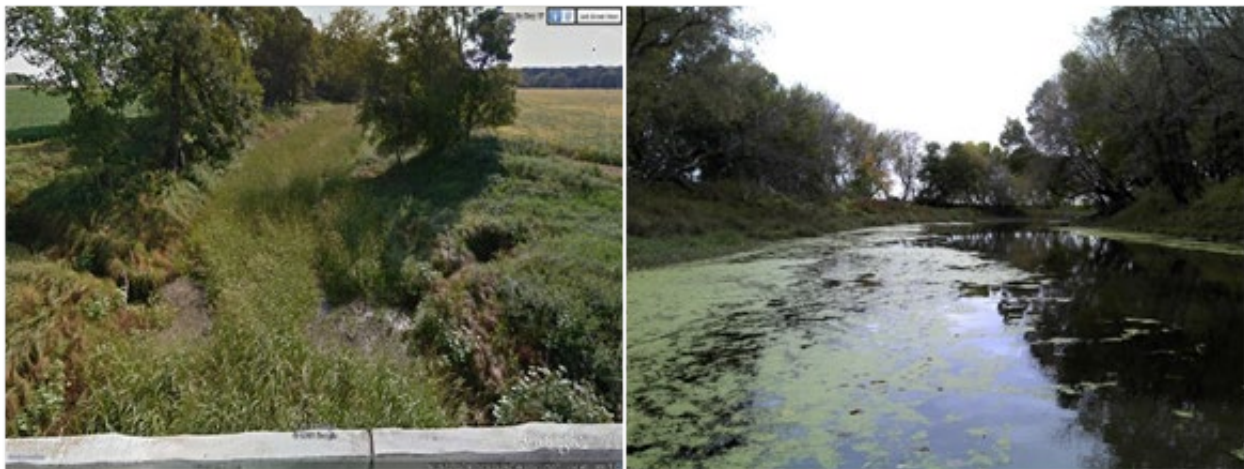
**Figure 19. Images of low flow conditions along AUID 537, including the CSAH 17 crossing during August 2012 (left), courtesy of Google Earth; and Station 13RD080 on September 22, 2015 (right).**

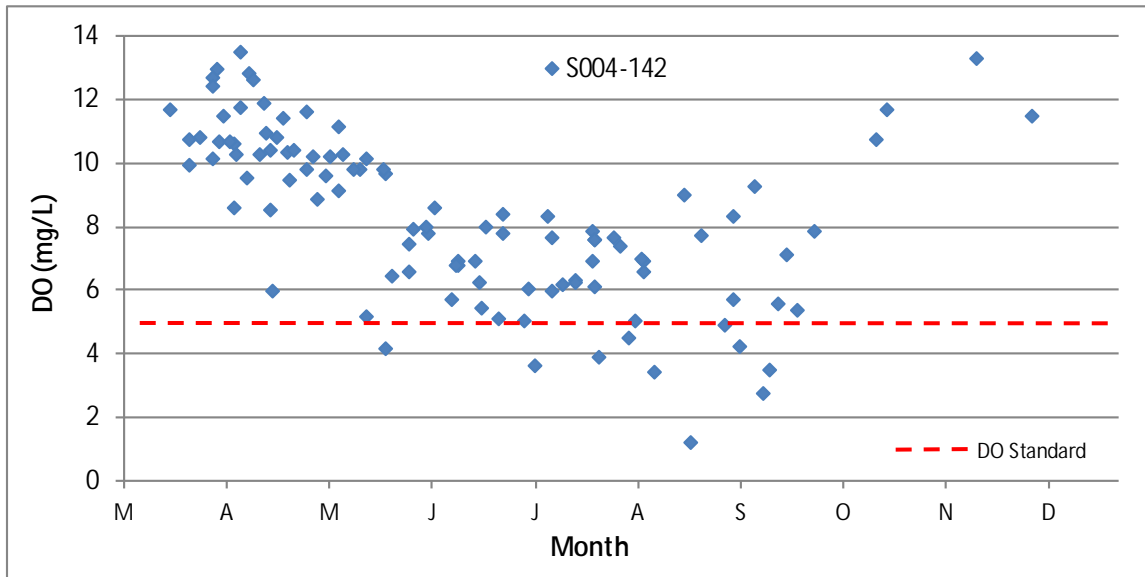
Figure 22. Discrete DO data for Site S004-142 (1998-2014;  $n=105$ ) along AUID 537.

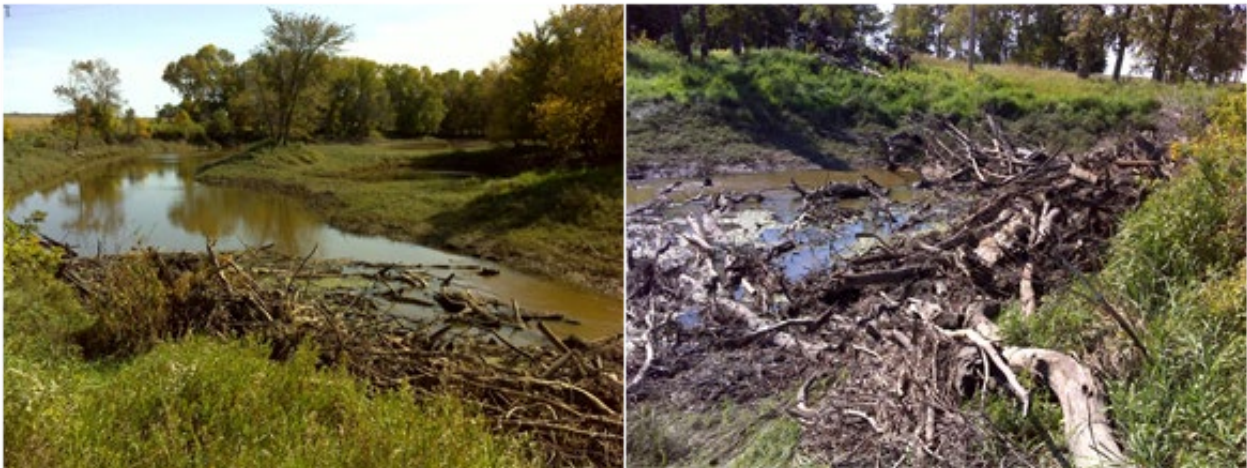
Figure 24. Images of a log jam located at the 330<sup>th</sup> Street NW crossing along AUID 502 on September 21, 2016.

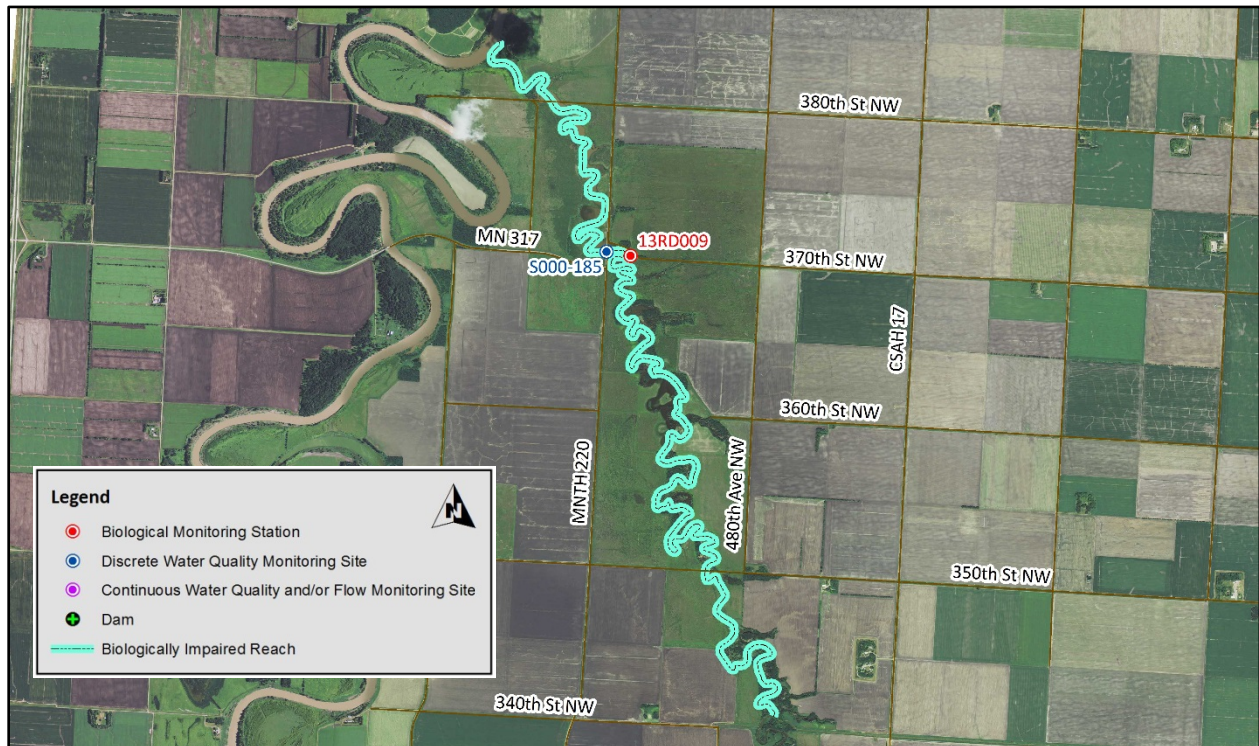
Figure 28. Map of AUID 501 and associated biological monitoring station and water quality monitoring site (2013 NAIP aerial image).

AUID 501 represents the segment of the Snake River from its confluence with the Middle River, to its confluence with the Red River of the North (Figure 28); a total length of 10 miles. The reach has a subwatershed area of 779 square miles (498,543 acres). The subwatershed contains 434 miles of intermittent drainage ditch, 352 miles of intermittent stream, 185 miles of river (which includes AUID 501), 32 miles of perennial drainage ditch, and three miles of perennial stream (MDNR, 2003). According to the MPCA (2013), 52% of the watercourses in the subwatershed have been physically altered (i.e., channelized, ditched, or impounded); the entire length of AUID 501 is classified as natural. The NLCD 2011 (USGS, 2011) lists cultivated crops (79%) as the predominant land cover in the subwatershed. Other notable land cover groups in the subwatershed included wetlands (7%), forest (6%), developed (5%), and hay/pasture (3%).

The fish community of AUID 501 was monitored at Station 13RD009 (0.2 mile upstream of the State Highway 220 crossing) on August 7, 2013. The location of the station is shown in Figure 28. The station was designated as General Use within the Southern Rivers FIBI Class. Accordingly, the impairment threshold for the station is an FIBI score of 49. Monitoring of the station yielded a FIBI score of 44. Overall, the fish assemblage of the station was dominated by fathead minnow and spotfin shiner. However, several longer-lived, riverine species (e.g., goldeye, quillback, sauger, and walleye) were sampled at the station, which is likely the result of the close proximity and unimpeded connectivity to the Red River of the North.

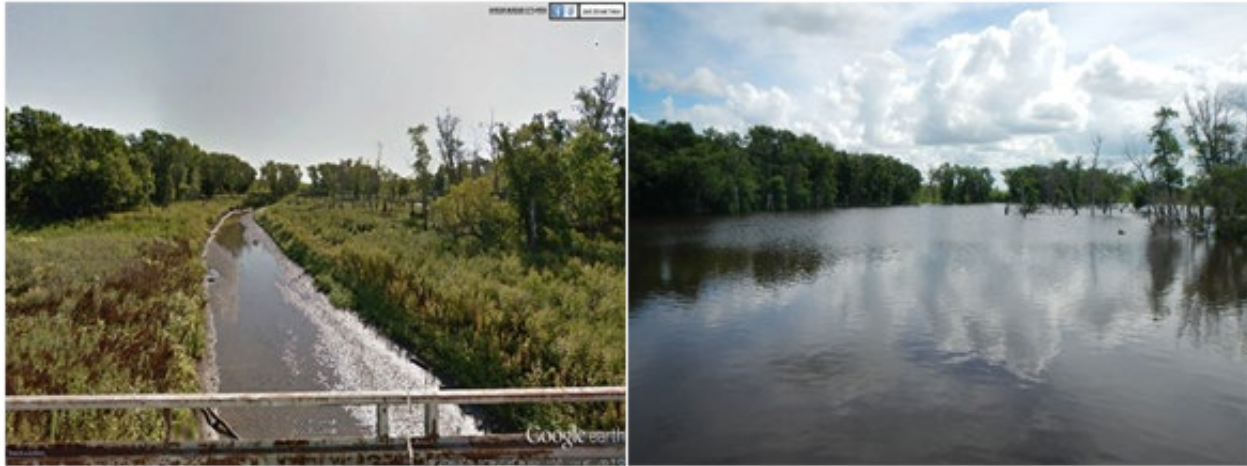
Figure 29. Images of stage variability at the State Highway 220 crossing along AUID 501, including low stage conditions during August 2012 (left), courtesy of Google Earth; and high stage conditions on June 23, 2014 (right).

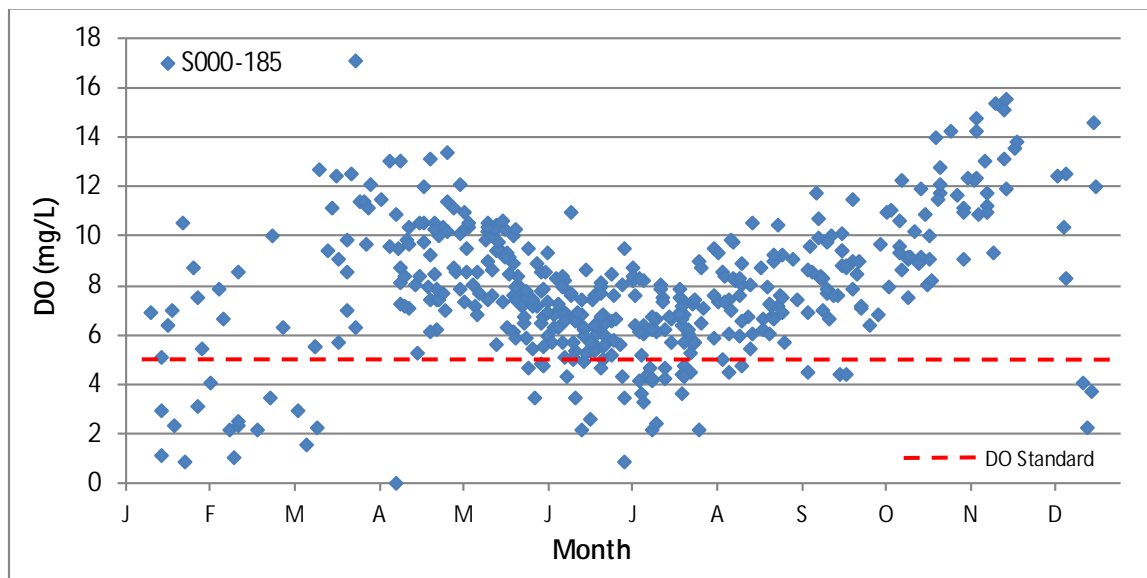
Figure 31. Discrete DO data for Site S000-185 (1971-2015;  $n=448$ ) along AUID 501.

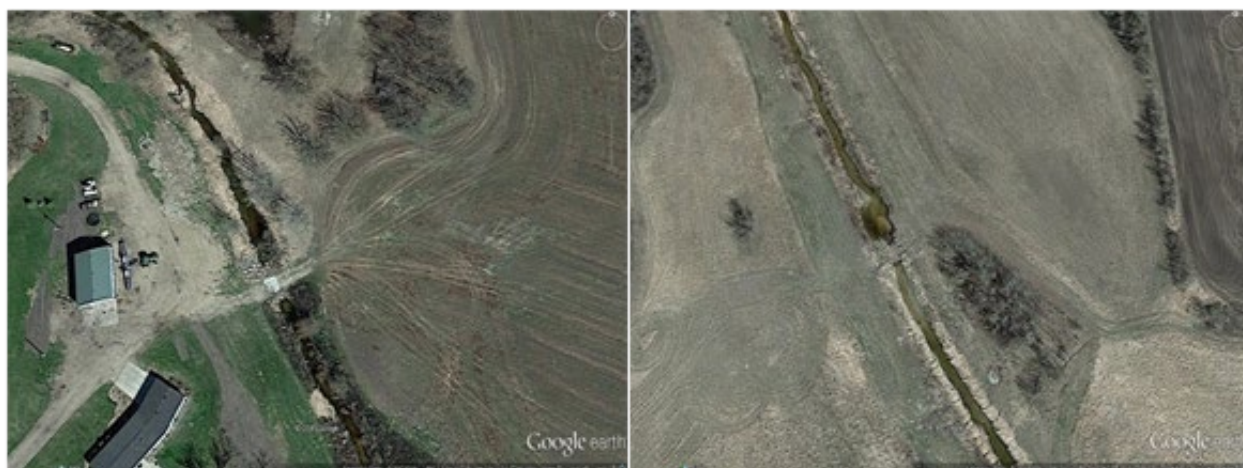
Figure 33. Images of potential connectivity barriers along AUID 546, including a private road crossing near 180<sup>th</sup> Avenue NW on April 29, 2016 (left), courtesy of Google Earth; and a private road crossing near CR 107 on April 29, 2016 (right), courtesy of Google Earth.

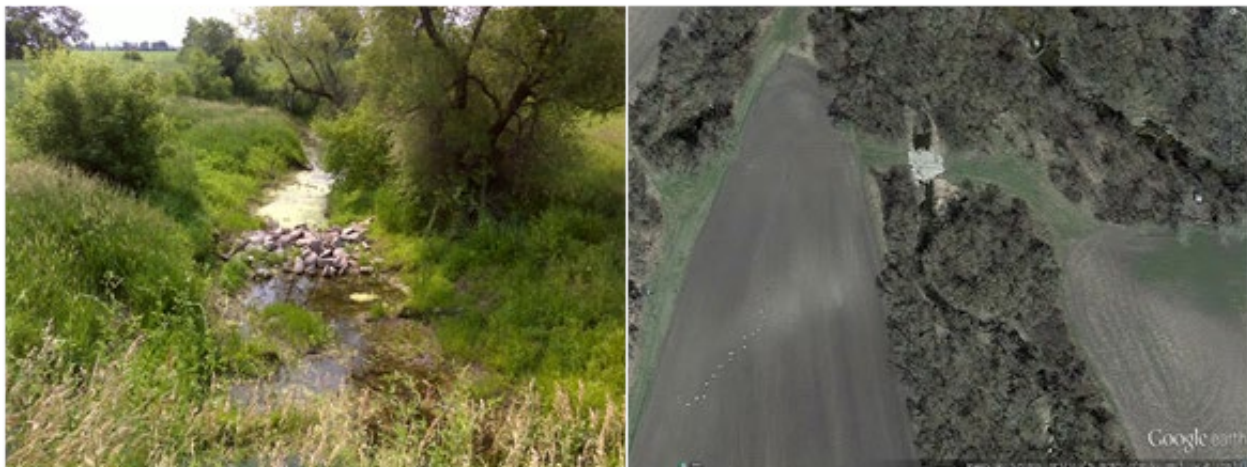
Figure 37. Images of connectivity barriers along AUID 544, including rock check dam upstream of the State Highway 1 crossing on July 1, 2015 (left); and a private road crossing near the confluence with the Snake River on April 29, 2016 (right), courtesy of Google Earth.

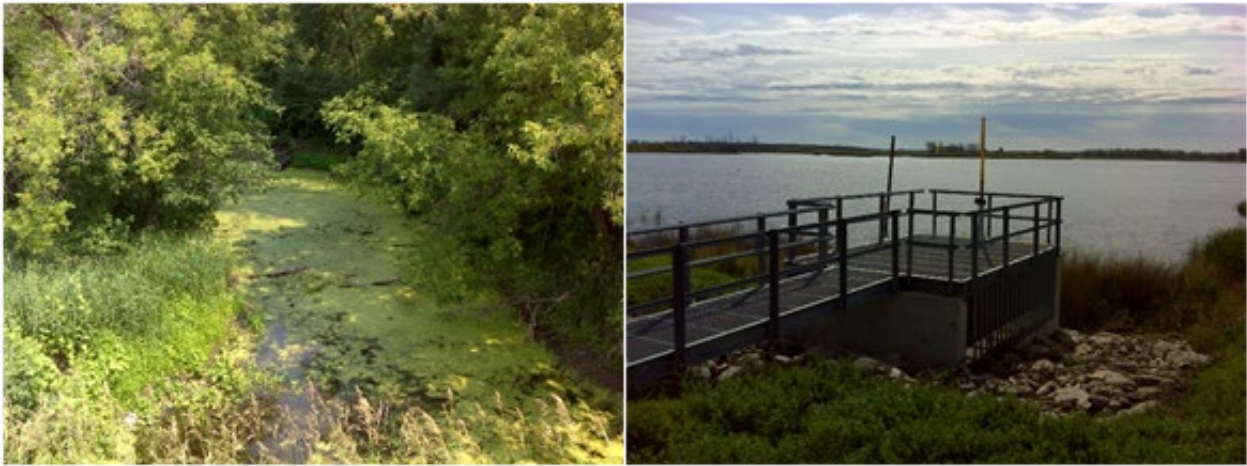
Figure 38. Images of flow regime-related issues related to AUID 544, including stagnant conditions at the State Highway 1 crossing on July 1, 2015 (left); and the Agassiz Valley Water Resource Management Impoundment on September 21, 2016 (right).

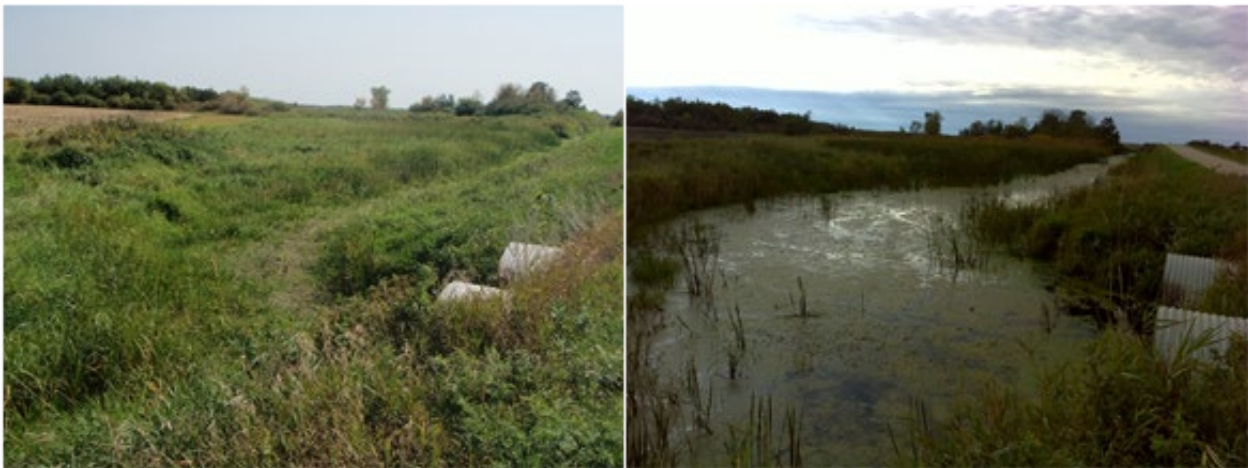
Figure 42. Images of flow intermittency at the 150<sup>th</sup> Avenue NE crossing along AUID 538, including a dry channel on August 6, 2013 (left); and lentic conditions on September 23, 2015 (right).

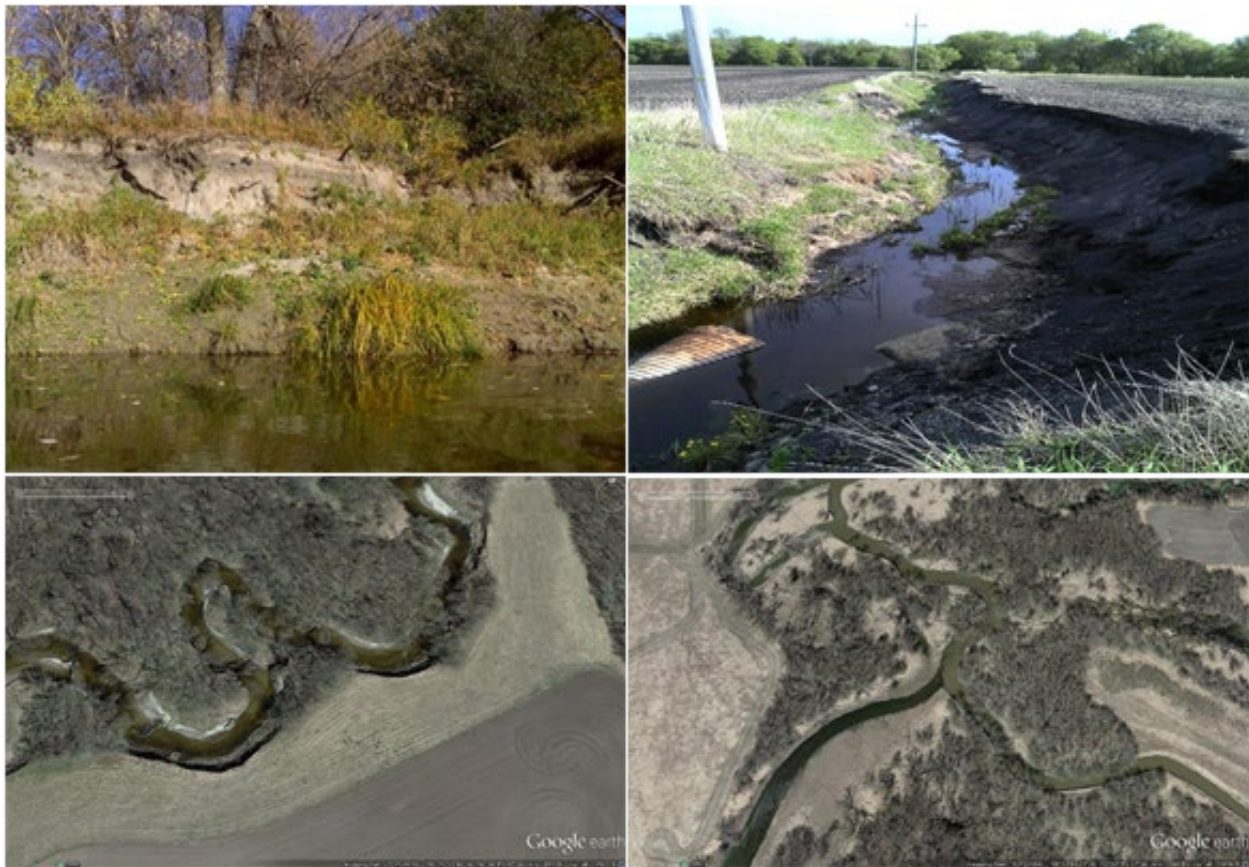
Figure 49. Images of sediment-related issues associated with AUID 540, including bank erosion at Station 93RD417 on October 20, 2014 (upper left), courtesy of Clark and Vinje (2017); bank erosion along an unnamed ditch tributary at the 330<sup>th</sup> Street NW and 370<sup>th</sup> Avenue NW crossing (upper right), courtesy of Clark and Vinje (2017); bank erosion near 310<sup>th</sup> Street NW (lower left), courtesy of Google Earth; and the confluence of the Middle River (light brown colored due to high TSS) and the Snake River (dark colored due to relatively low TSS) (lower right), courtesy of Google Earth.

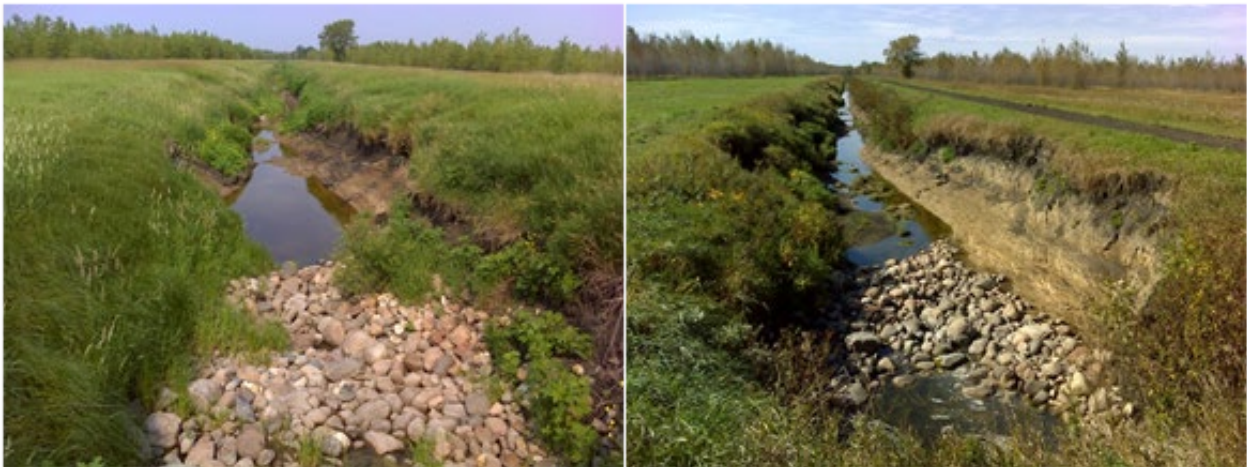
Figure 56. Images of a rock check dam at the 480<sup>th</sup> Avenue NW crossing along AUID 519 on July 1, 2015 (left) and September 21, 2016 (right).

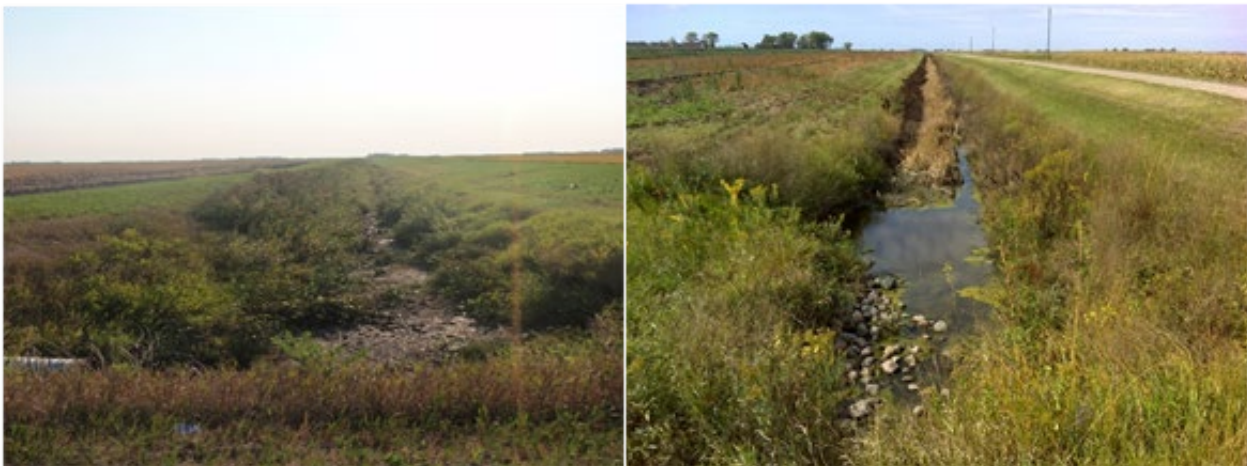
Figure 57. Images of flow intermittency along AUID 519, including Station 13RD010 on August 6, 2013 (left); and the 390<sup>th</sup> Avenue NW crossing on September 21, 2016 (right).

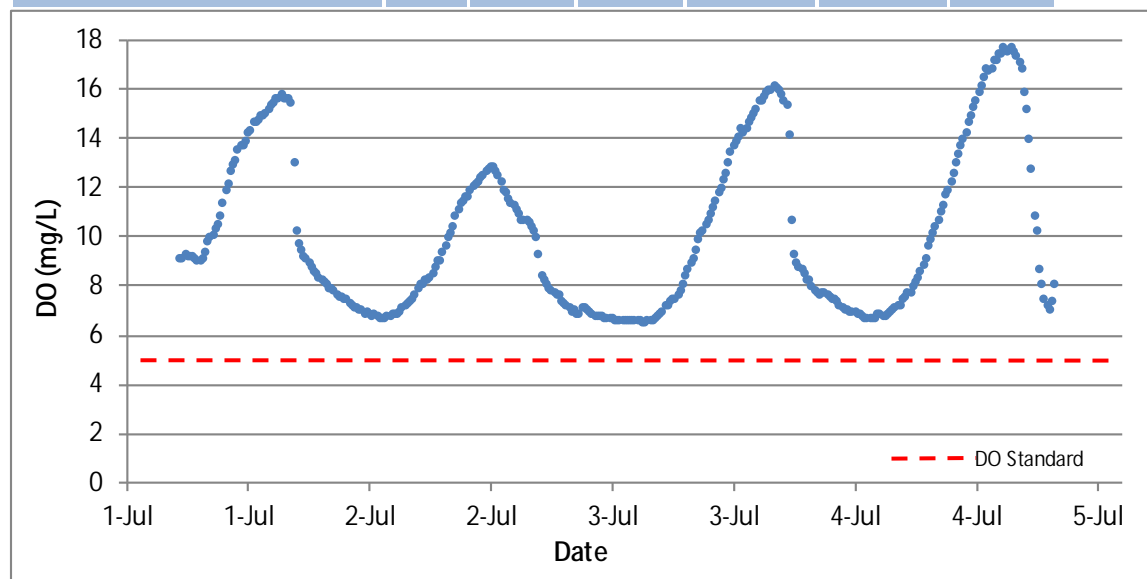
Figure 59. Continuous DO data for Site W68013001 (2015; n=347) along AUID 519.
