# Summary - Lower Red River Watershed Restoration and Protection Strategies (WRAPS) Report

The Lower Red River Watershed effort began in 2008 and produced a Watershed Restoration and Protection Strategies (WRAPS) Report that was published in April 2018. Summarized in this document are key findings and recommendations contained in the full report.

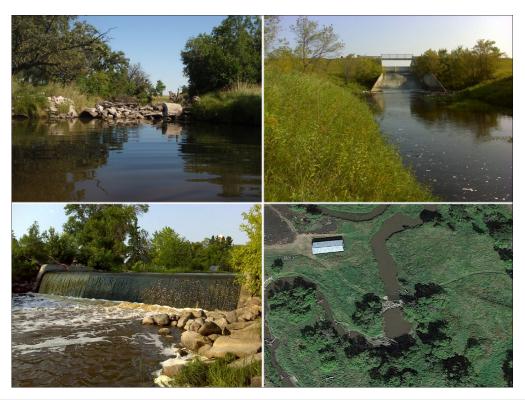
Photos of barriers to fish movement include the remnants of a private stream crossing taken in 2008 (upper left), the Florian Dam taken in 2015 (upper right), the Stephen Dam taken in 2014 (lower left), and the remnants of another private stream crossing downstream of 330th Ave. NW taken in 2013 (lower right, courtesy Google Earth).
